Repair Ability of Incoloy 800 in Vent Gas Wash Tower Pipe System

Abstract

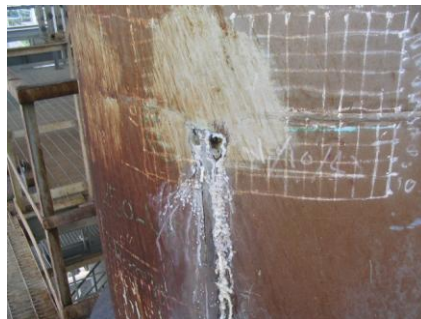
However, it is found that after 9 months of service corrosion is observed. Hazard gas is leaked near the weld as shown in figure 1. Failure analysis was conducted in order to investigate the root cause of corrosion and prepare corrective action to prevent any leakage.

Figure 1: Incoloy 800 pipe leakage by corrosion attack.

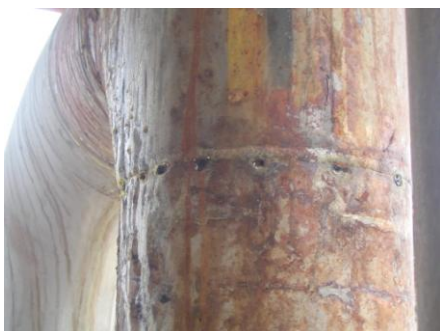
The investigation of failure pipe showed that many corroded holes appeared in Heat Affected Zone (HAZ) as shown in figure 2. The possible assumptions of this corrosion may be the result of:

- Welding heat may damage corrosion properties of heat affected zone.
- The filler metal is not compatible with Incoloy 800 resulting in galvanic corrosion.

Figure 2: Corroded holes at HAZ of the Incoloy 800 pipe after 9 months of service.

The ERNiMo-7 (Inconel 665) was previously used for joining of Incoloy 800 pipe resulting in severe corrosion attack by HCl environment as shown in figure 2. In this research, four filler metal classifications used to comparatively study repair ability of Incoloy 800 were ERNiCrCoMo-1 (Inconel

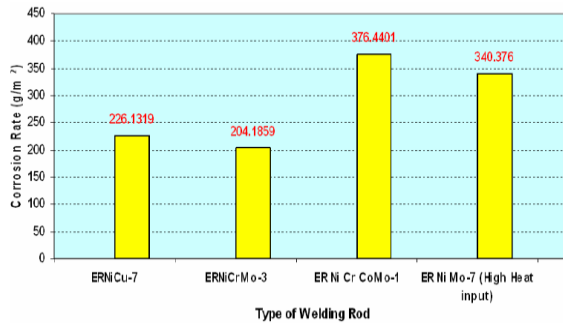
Corrosion in actual service might take at least 7-9 month; therefore, in this study, accelerated corrosion test was performed by using hydrochloric acid with 38% concentration and PH of 0.74. Temperature was held constant at 50 °C throughout experiment. The tests were performed for 70 hours and then the

samples were weighted to determine weight loss per exposed area.

Figure 5: Corrosion rate resulting from accelerated corrosion test in HCl 38% for 70 hours

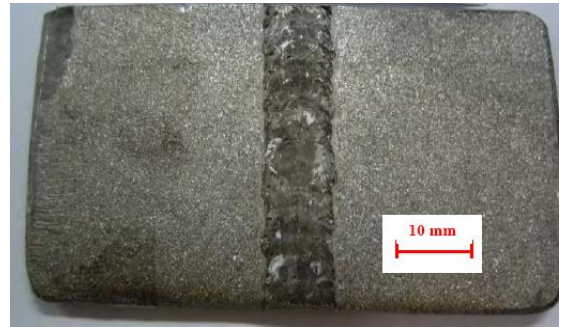
Figure 6 showed photography of specimens after immersion in hydrochloric acid for 70 hours. ERNiCrMo-3 and ERNiCu-7 weld metal showed no corrosion on weld face as it could be seen in figure 6a and 6b, respectively. However uniform corrosion was appeared at heat affected zone and base metal area. Most of metal loss came from Incoloy 800 base metal (anodic reaction).

Figure 6 (cont): Specimens welded by (a) ERNiCu-7, (b) ERNiCrMo-3 (c) ERNiCrCoMo-1 and (d) ERNiMo-7 tested in HCl 38 % for 70 hours

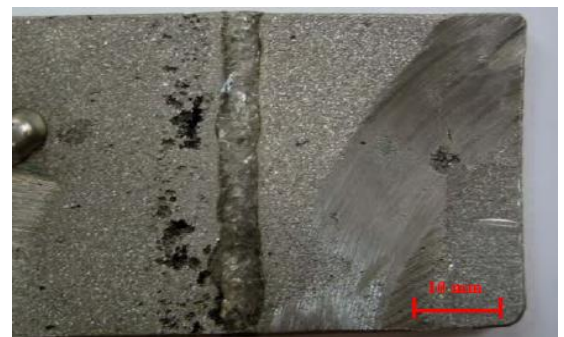
(d)

ERNiMo-7 welded (Inconel 665) specimen required higher heat input comparing with those of other filler metal used in this study. It can be clearly seen in figure 6d that severe localized corrosion occurred at heat affected zone area. Figure 7 and Figure 8 showed the crevice corrosion at the weld toe region of cover pass side and root pass side. These crevice corrosions appeared to be at small *overlap* between weld metal and base metal. Liquid weld pool of ERNiMo-7 was quite viscous and tended to promote overlap therefore higher heat input was usually required. This might damage corrosion properties at heat affected zone area. Figure 9 showed localized attack corrosion at coarse grain region at heat affected zone. The coarse grain was resulted from higher heat input condition.
